Manhole Inspection Summary

Manhole # S21GG_040MH

Insp Date: **6/26/09 10:41 AM**

Location Address: **1605 FULTON AVE**

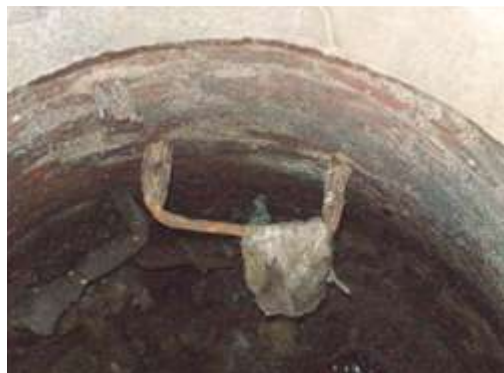
Defect 7

Count: **5** Missing: **1** ☒ **Corroded**

CORRODED STEP AND MISSING ONE

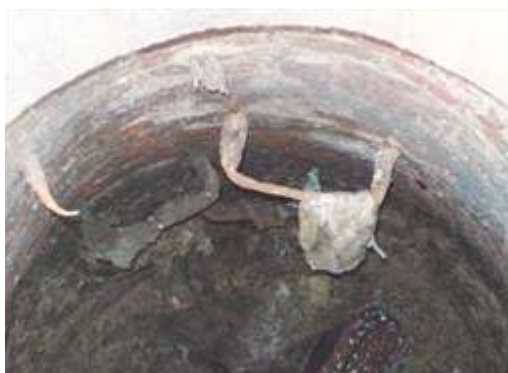
Defect 6

☒ **Evidence Of Surcharge**

Depth: **3.2** (ft.) ☐ Active Surcharge Present

CORRODED STEPS AND EVIDENCE OF ASUR

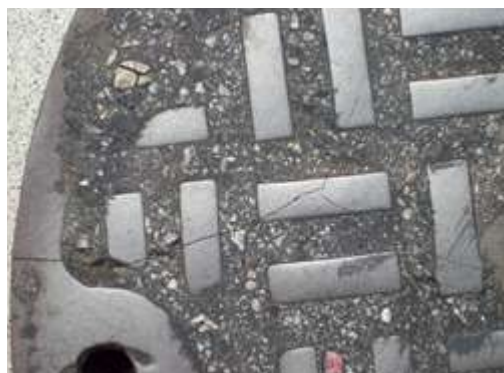
Defect 5

Condition: **Cracked**

CRACKED COVER

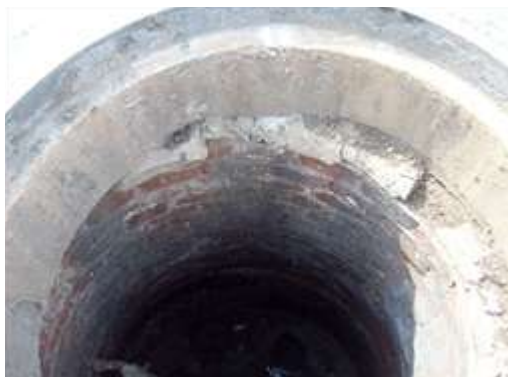
Defect 4

Offset: **2** (in.)

FRAME OFFSET

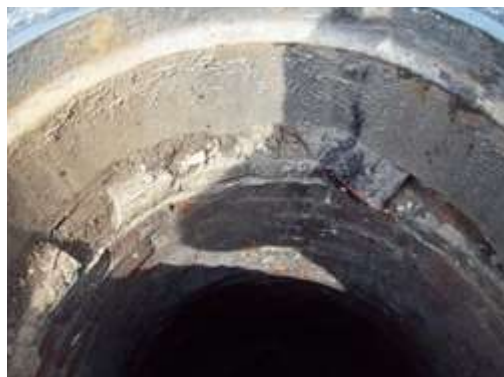
Defect 3

Condition: ☐ Sound ☒ **Cracked** ☐ Root Intrusion ☐ Loose Brick ☐ Deteriorated

CRAKCED CORBEL

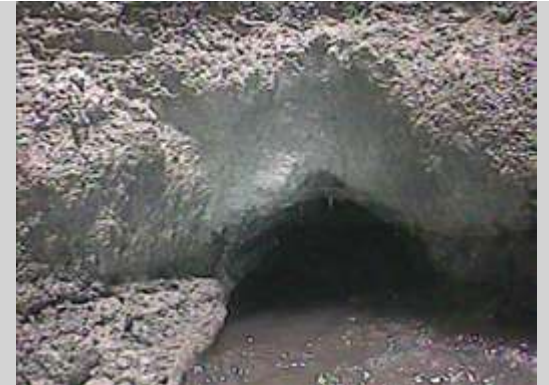
12 O'Clock Outflow

Deposits: ☐ None ☐ Mud ☐ Sludge ☒ **Debris** ☐ Grease

Silt Depth: **3** (in.) Deposits Extent: **Heavy**

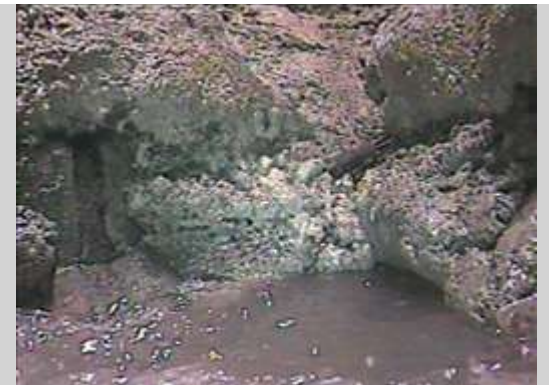
3 O'Clock Inflow

CLOGGED PIPE

Deposits: ☐ None ☐ Mud ☒ **Sludge** ☒ **Debris** ☐ Grease

Silt Depth: **8** (in.) Deposits Extent: **Heavy**
